RCRA FACILITY ASSESSMENT

EVERGREEN OIL, INC. 6880 Smith Avenue Newark, California 94560 EPA ID No. CAD 980887418

California Environmental Protection Agency
Department of Toxic Substances Control
Region 2
700 Heinz Avenue, Building "F"
Berkeley, California 94710

APRIL 1993

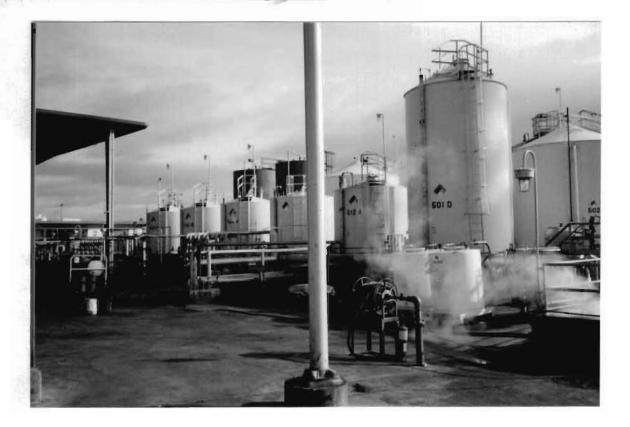
However, the containment area on the western section of the tank farm was accessible (See photos #3 and #5). Inspection of this area of the tank farm revealed the presence of cracks (See photo #6). It is not known if some of the cracks on the floor extend to the bottom of the tanks. A layer of oily liquid sat in the northwestern corner of the tank farm (See photo #7). Evergreen stated that the containment floor is sloped to this corner; therefore, oily residues on the floor and

Photo #3: Photo of the tank farm. These tanks on the western side of the tank farm are used for the storage of waste oil. Photo facing east.

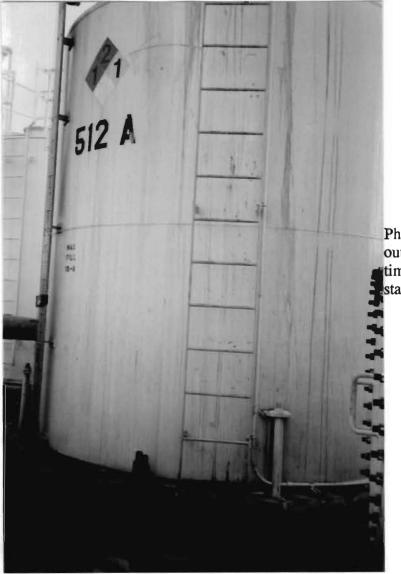
Photo #4: Tank 512A is currently out of service. The tank, at one time, stored waste oil. Note the stains on the exterior of the tank.

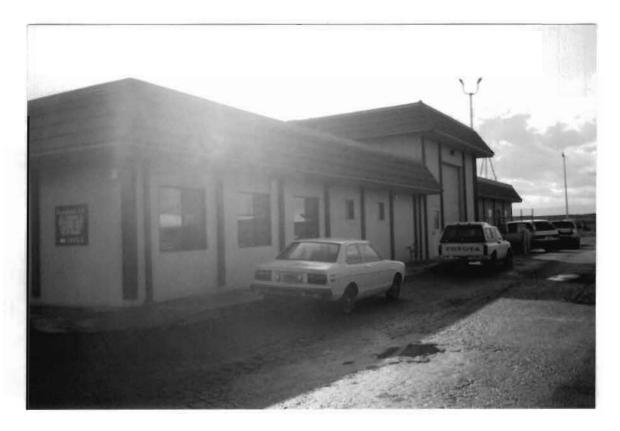
Photo #1: Photo of Evergreen Oil, Inc., located at 6880 Smith Ave.

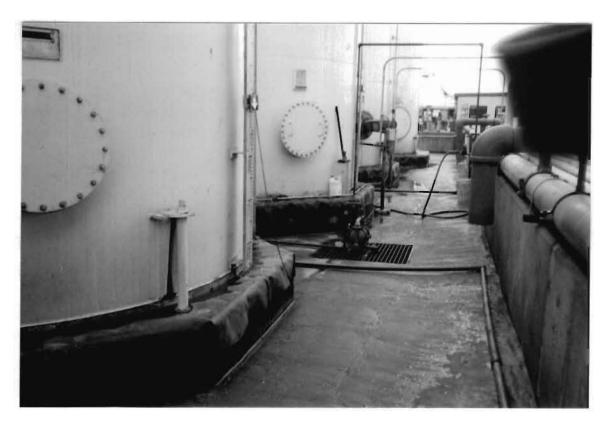
Photo #5: The western section of the tank farm appeared fairly clean. The liquid on the containment floor is rainwater. Photo facing south.

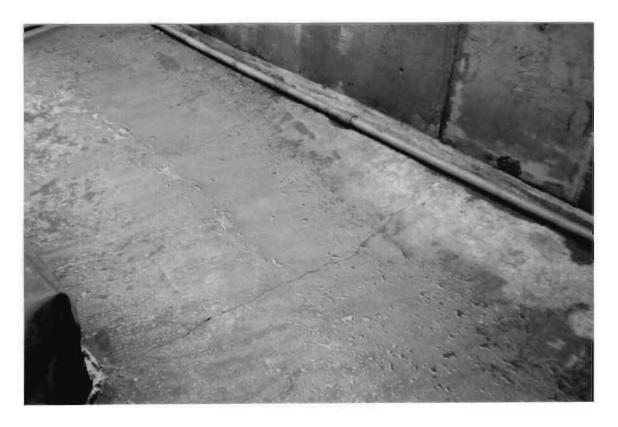
There is a medium potential for releases to soil and/or groundwater because of the cracks and stains present in many areas of the tank farm. Furthermore, since no chemical resistant coating is provided for the secondary containment, the potential for spills to seep through the cracks is high.

Photo #6: Photo of crack on the containment floor noted in the western section of the tank farm.

The SWMUs listed above do not provide adequate secondary containment. Since cracks, gaps, and deterioration were found in the secondary containment, it is recommended that improvements be made. Furthermore, it is recommended that a specific area in the process area, identified in photos #16 and #17 be investigated for possible soil and groundwater contamination.

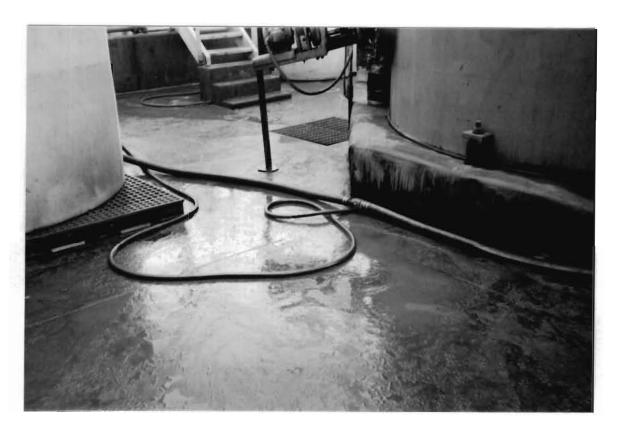
rainwater were drained to this corner. This area was quite hazardous to walk on because of the oil slick.

Photo #7: Photo of the northwestern corner of the tank farm. Note the layer of oil on the floor. Evergreen explained that the slope of the floor caused rainwater mixed with oil residue to run off to this area. Therefore, the oil slick was much more concentrated in this corner. Photo facing northeast.

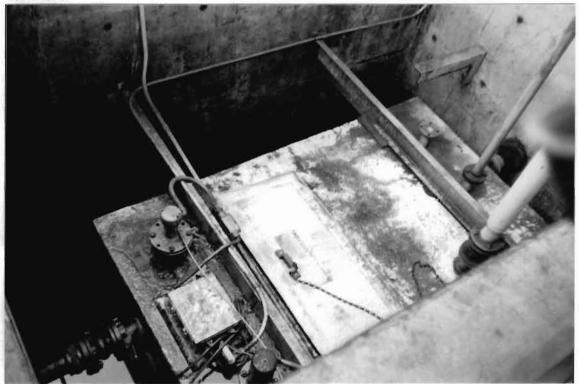
Liquid in the secondary containment of the tank farm sump X-508 was observed (See photo #8). Evergreen stated that the liquid is rainwater. Since this unit is underground, inspection for cracks and stains of the unit and its secondary containment was not possible.

Photo #8: Photo of sump X-508 that is used as the secondary containment for the tank farm. Photo facing southeast.

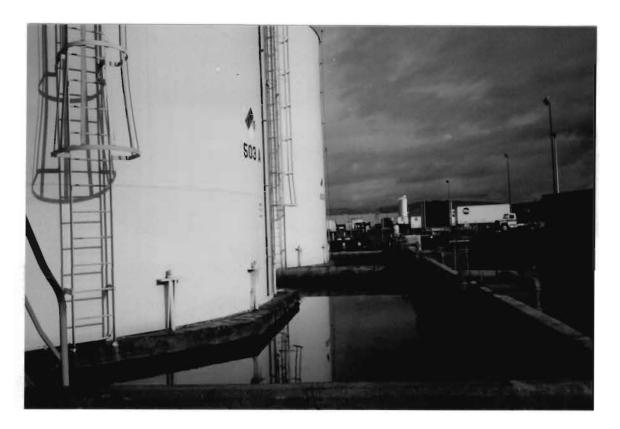
Rainwater had accumulated in many of the cells of the tank farm. In cells containing hazardous wastes tanks T-503A and T-504B, rainwater was estimated to be about a foot deep (See photos #9 and #10). Therefore, visual inspection of the containment floor was not feasible.

Photo #9: Photo of tanks located on the eastern side of the tank farm. Note the level of rainwater accumulated in the tank farm. The container storage area can be seen in the background. Photo facing east.

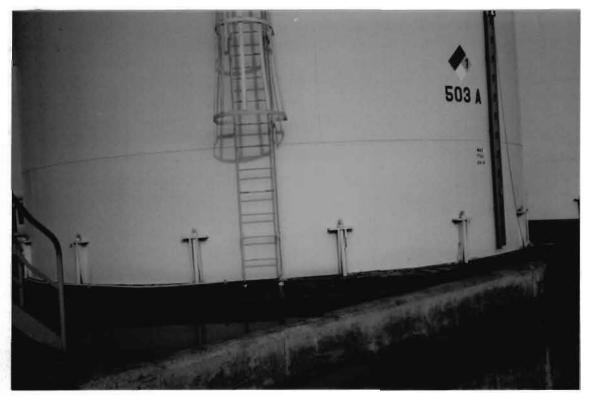
Photo #10: Photo of Tank 503A. Tank 503A is a 200,000 gallon tank used for storing used oil feedstock.

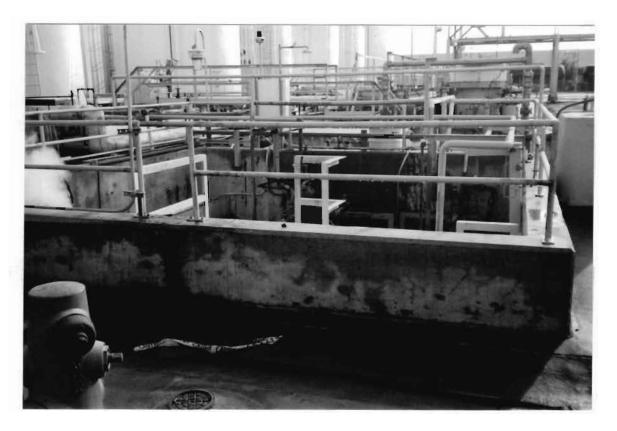
The oily water separators are below ground units and surrounded by a containment wall (See photos #11 and #12). Both of the oily water separators are situated in the same secondary containment area. Since these units are below ground, inspection for cracks and stains of the units and the secondary containment was not possible.

Photo #11: The oily water separators are located below surface and surrounded by a containment wall.

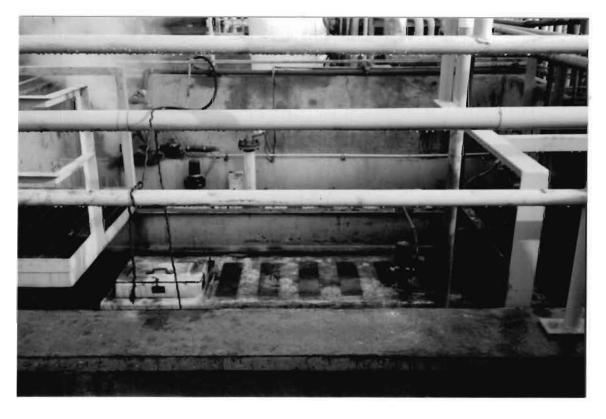
Photo #12: Both of the oily water separators, X-453 and X-454, are situated in the same secondary containment area.

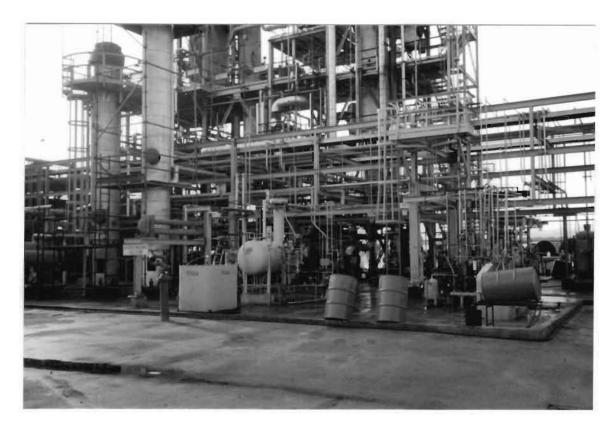
The process area, measuring approximately 12,500 square feet in size, is located south of the tank farm (See photo #13). Waste oil stored in the tank farm is piped to this area for processing. The treatment of hazardous waste oil to non-hazardous waste oil utilizes five major vessels.

Photo #13: Photo of the Process Area. Photo facing southeast.

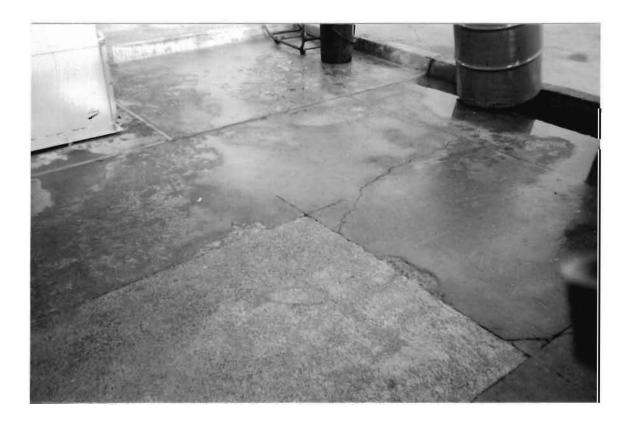
Stains and cracks were very evident in many areas of the process area (See photos #14, #15, #20, and #21). In one particular area, it appeared that a strong chemical had spilled and eaten the concrete block and floor (See photos #16 and #17). In another area, an oil-like material was observed leaking from a pump (See photos #18 and #19). Evergreen stated that the pump was packed earlier that morning; therefore, the leak resulted.

There is a high potential for releases to soil and/or groundwater because of the cracks and gaps present in many areas of the process area. Furthermore, since no chemical resistant coating is provided for the secondary containment, the potential for spills to seep through the cracks is high. At the time of the VSI, the containment floor did not appear to be well maintained. This factor may also increase the potential for accidents to occur.

Photo #14: Note the cracks and chips of the concrete floor in the Process Area. Photo facing north.

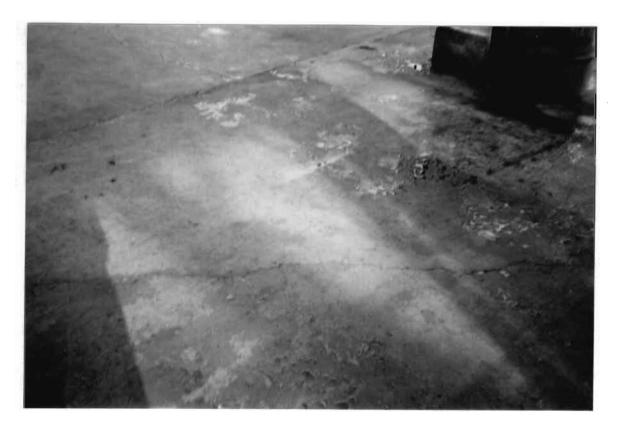
Photo #15: Photo of a crack observed in the Process Area.

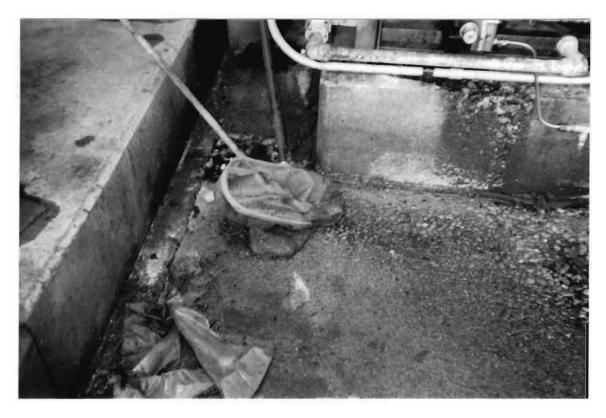
Photo #16: It appeared that a strong chemical spilled and ate some of the concrete block and the concrete floor. This section of the Process area was not uniformly paved like the other sections of the Process Area. Also note that the floor to the left of the net is severly cracked.

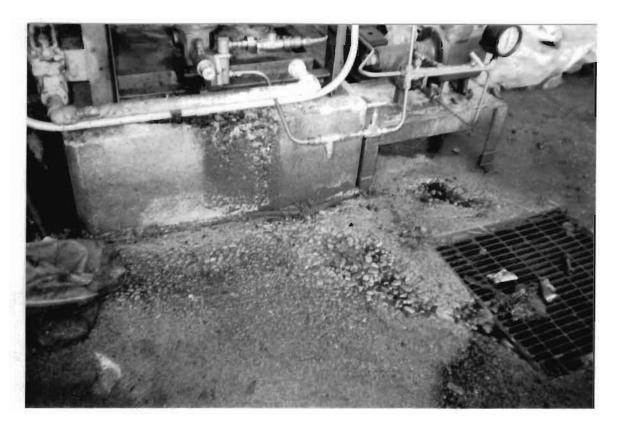
Photo #17: Photo shows a different angle of Photo #16. The sump close by most likely contained the spill.

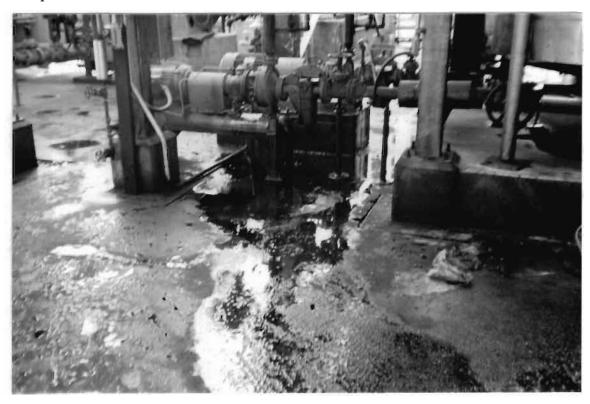
Photo #18: A leak was observed in this area of the Process Area. Evergreen explained that oil leaked when the pump was being packed. Photo facing south.

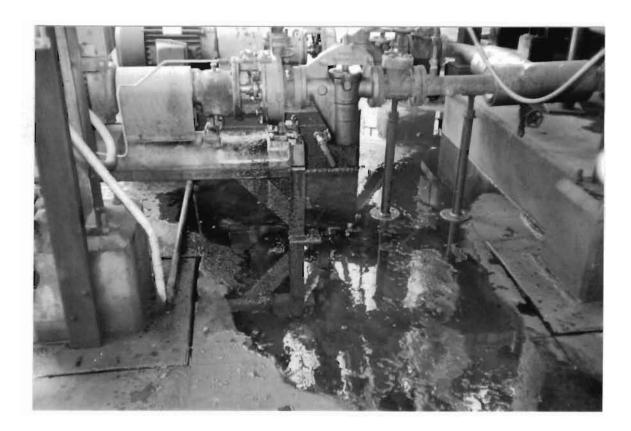
Photo #19: A close up view of the leak. Note the layer of oil mixed with probably rainwater on the ground.

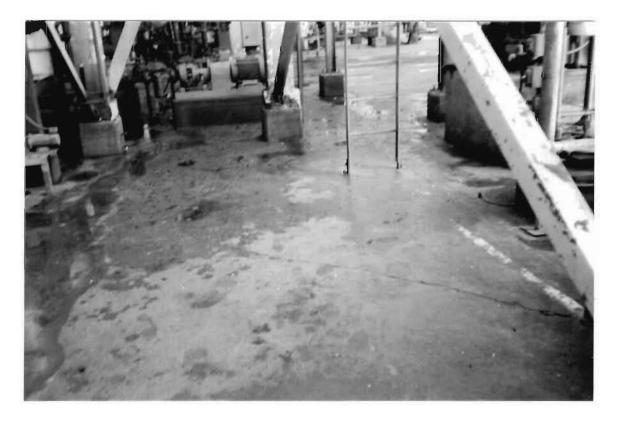
Photo #20: Photo of a crack in the Process Area. Photo facing west.

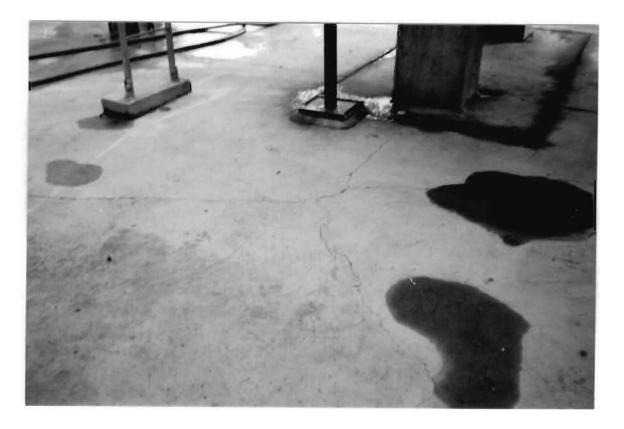
Photo #21: Photo of cracks in the Process Area.

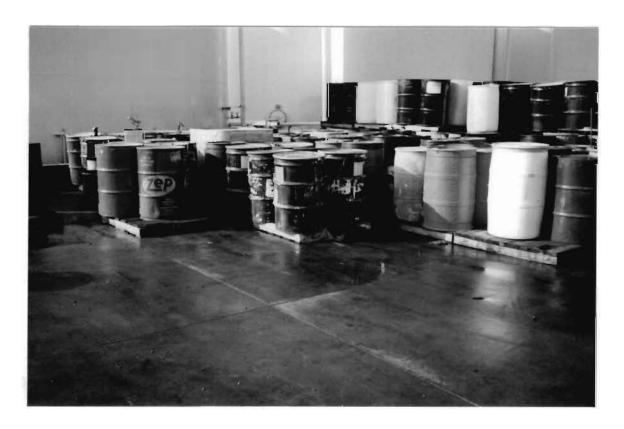
The container storage area is located in the northeast portion of the tank farm (See photos #22 and #23). It is one of the eleven cells discussed in SWMU #1. The approximate size of this storage unit is 900 square feet with an exterior berm height of 3 feet. The interior berm walls which separate adjacent cells are 1'6" high. A roof is not provided for this area nor is chemical resistant coating provided for the secondary containment.

Photo #22: Photo of the container storage area. Photo facing west.

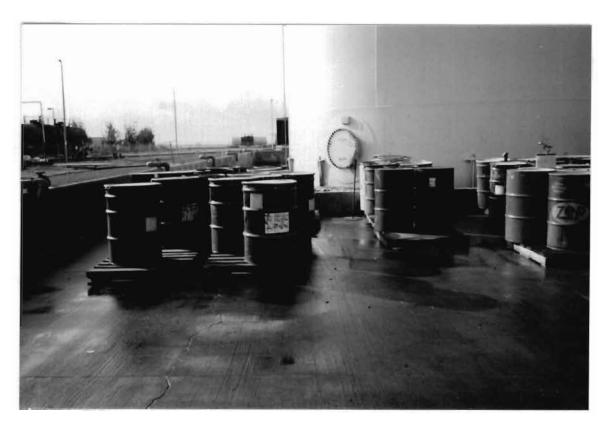
There is a medium potential for past and/or on-going releases to soil and groundwater. The conclusion is supported by the fact that cracks are very evident throughout the container storage area and especially around the sump. Oily stains were visible in one area of the container storage area. Furthermore, the Department had cited Evergreen in the Feb 1992 inspection for not maintaining and operating the container storage area to minimize the possibility of the release of hazardous waste or hazardous waste constituents to air, soil, or surface water.

Photo #23: Photo of the container storage area. Note the crack on the containment floor. Photo facing west.

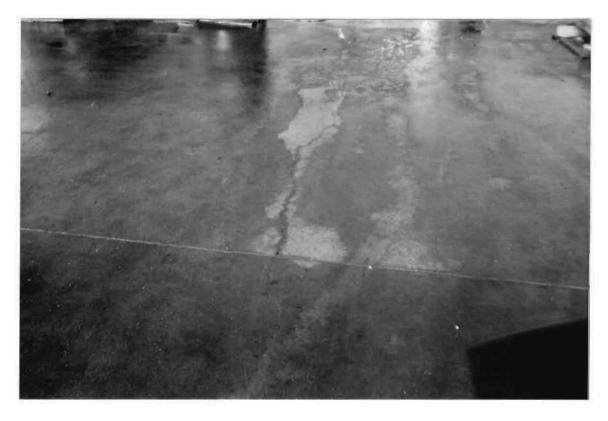
Photo #24: Photo of another crack on the containment floor of the container storage area.

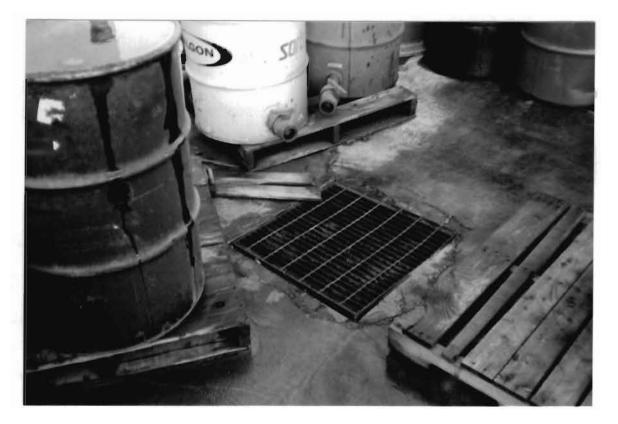
Aisle space was not adequately provided for the container storage area. On one side of the storage area, containers were clustered together so that one could not walk through rows of containers. An open paint can containing what Evergreen stated to be lube oil was observed (See photo #26). Some of the oil had spilled onto the containment floor. Cracks were present (See photo #24), particularly around the sump in the northern section of the container storage area where the cracks were quite extensive (See photo #25). Sheens of oil were also noted around the sump.

Photo #25: Photo of a sump in the container storage area. Note the condition of the concrete surrounding this sump. Also note some stains around this area.

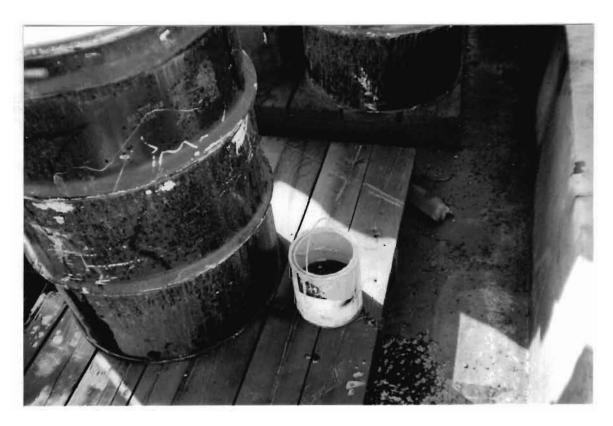
Photo #26: During the VSI, an open can of lube oil was observed in the container storage area. Some of this oil had spilled onto the floor. Photo facing southwest.

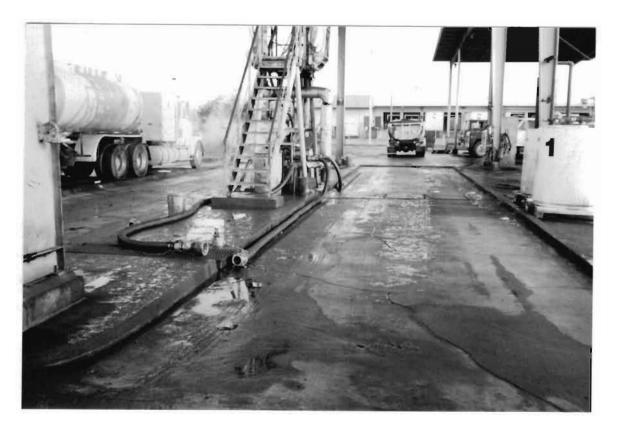
Photo #27: Photo of the tanker truck rack. Note the cracks on the containment floor. Most of the cracks have been filled. The bobtail rack is in the background. Photo facing north.

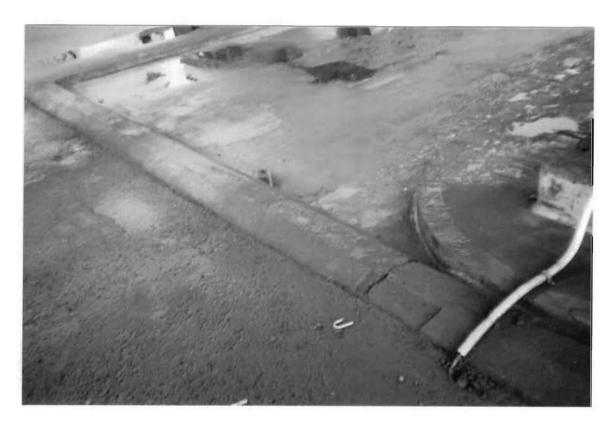
Cracks were evident in the tanker truck rack area. Some cracks were filled but others were not (See photos #29 and #30). Cracks were also observed on the berm (See photo #28). Gaps present between the berm and the containment floor were noted (See photo #32).

Photo #28: Photo of the tanker truck rack. Note the condition of the berm. The liquid in this area is rainwater.

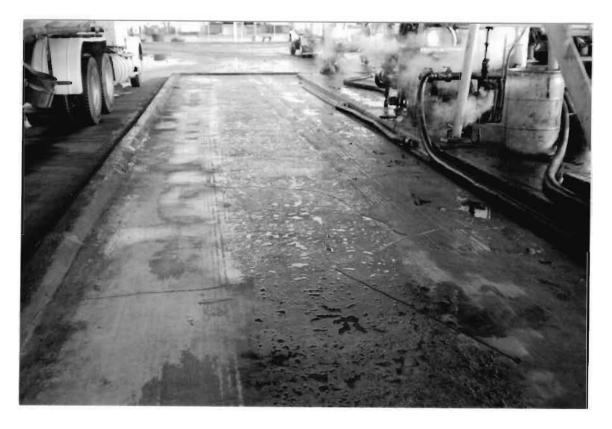
Photo #29: Photo of the tanker truck rack. Photo facing northeast.

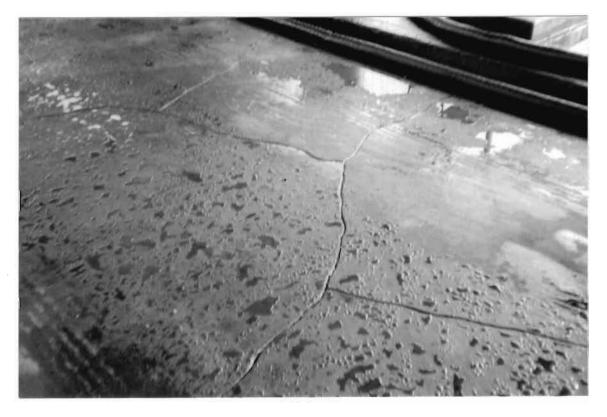
Photo #30: A close up view of the cracks that have been filled in the tanker truck rack.

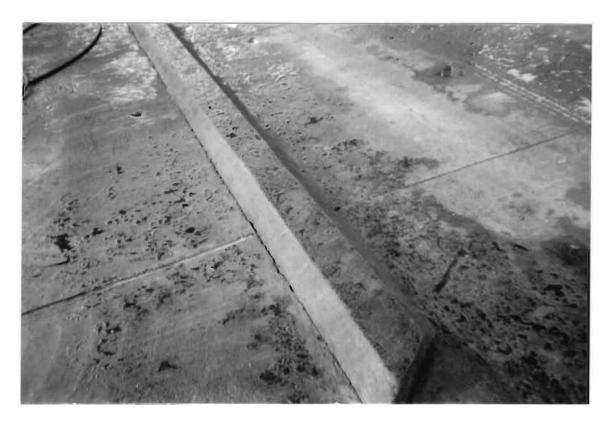
Photo #32: Note the gap between the berm and the containment floor.

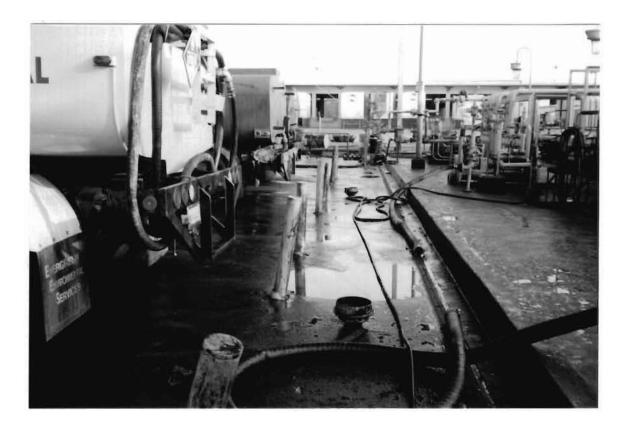
Like the tanker truck rack, cracks were also present in the bobtail loading rack (See photo #36). There were a few areas where spills have occurred, but were not cleaned up (See photo #35). These spills were light brownish in color and appeared creamy like. Stains were also observed and they appeared to be orange in color and provided a glow to the ground (See photos #33 and #34).

Photo #33: Photo of the bobtail rack. The orange glow on the floor appeared to have resulted from a past spill. The liquid on the floor is rainwater. Also note the funnels sitting on the floor. Photo facing northwest.

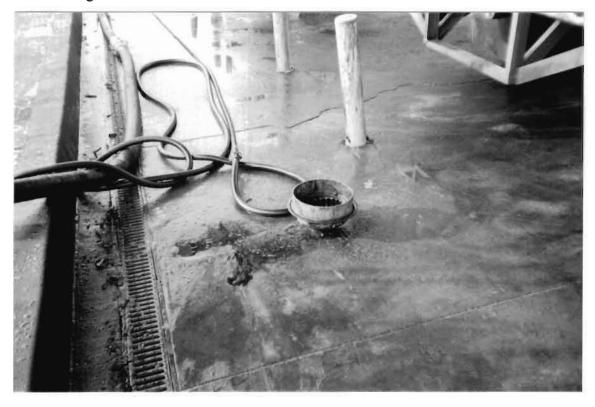
Photo #34: A close up view of a funnel. Note the orange brownish stains to the right of the funnel.

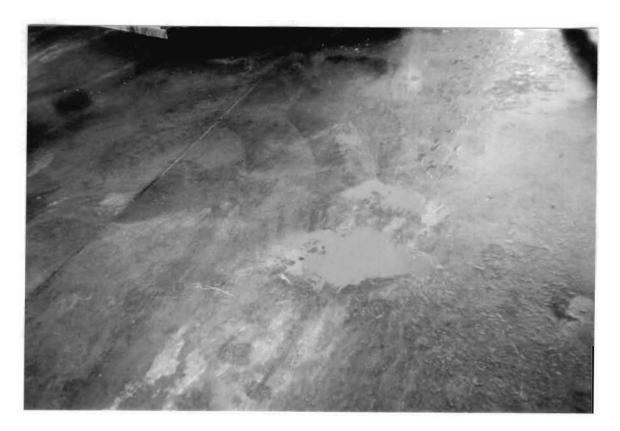
Photo #35: The brownish stain in this photo appeared to be some kind of spill. The spilled material is unknown. Other stains were also very evident around this bobtail rack. Photo facing northwest.

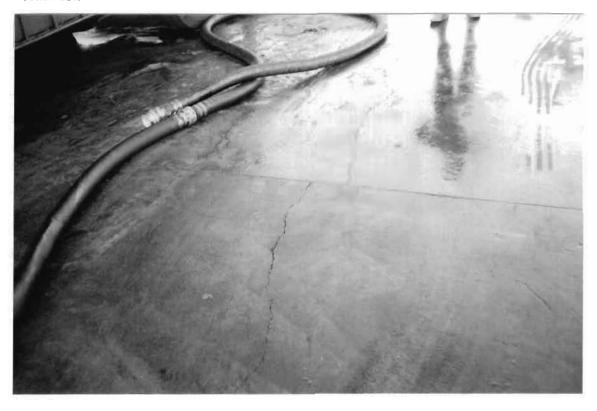
The potential for releases to soil and/or groundwater is high. There are many cracks and gaps present in both the bobtail and tanker truck rack areas. Some of the cracks were filled but others were not. Cracks were evident on the floors and berms. Stains and spills were also evident. The potential is compounded by the fact that the area is very poorly maintained.

Photo #36: Cracks are evident in the bobtail rack. These cracks are not filled. Also note the stains around the area of the hose.

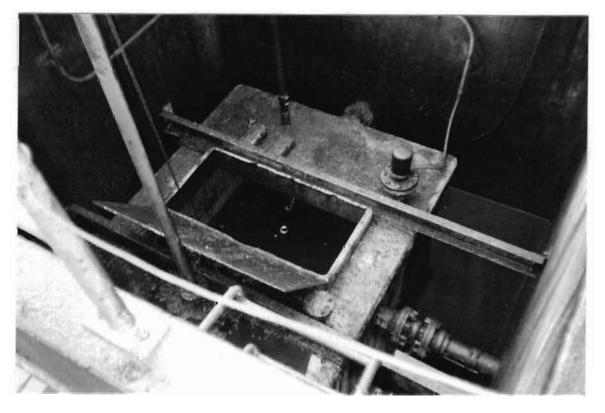
There was liquid in the secondary containment of the loading rack sump. Evergreen stated that the liquid is rainwater. The lid to the sump was open and debris were seen on top of the oily wastewater (See photo #38). Since this unit is underground, inspection for cracks and stains of the unit and its secondary containment was not possible.

Photo #38: Photo of sump X-510. Note that the cover to the sump was left open and some debris had fallen in.

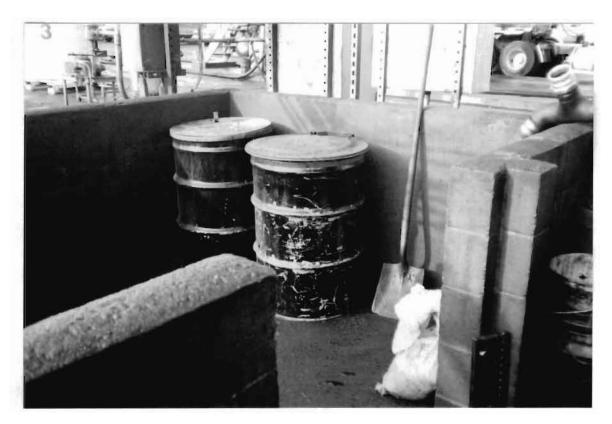
Photo #39: Photo of drums containing filtered debris. This unit is identified as the filter cleaning area (SWMU #6).

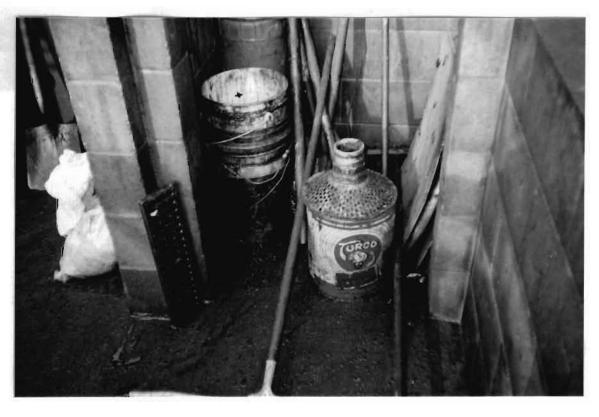
To the left of the entryway of the filter cleaning area is a metal rack where filters are placed for cleaning. There was a lot of debris collected in the metal bin (See photo #41). Debris included soda can, cups, and shredded papers. The lid which is to be placed on top of the metal rack was no where to be seen. A drainage system is located in corner of the area (See photo #42). The system contained a dark murky liquid with a sheen of oil on top. The rainwater and oil masked the condition of the floor; therefore, cracks and stains, if present, were not discernible. Buckets and tools used to clean up the filters sat in another corner of the unit (See photo #40). Since no roof is provided for this unit, rainwater may have washed oily residues on the buckets and tools to the ground.

Photo #40: Photo of buckets and tools used to clean up filters. The photo shows an area inside the filter cleaning area. Photo facing west.

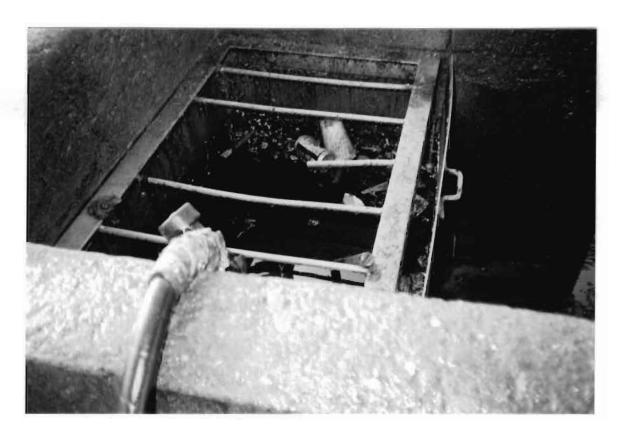
Photo #41: Photo of a metal rack used for cleaning filters. Note the debris inside the metal bin. A lid is supposed to cover the bin, but at the time of the VSI, the lid was nowhere in site. The filter cleaning area is identified as SWMU #6.

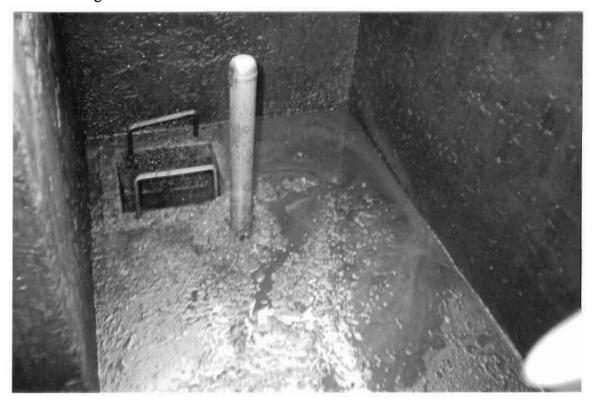
Photo #42: Photo of sump in the filter wash area. Note the slick of oil mixed with rainwater on the floor. Photo facing south.

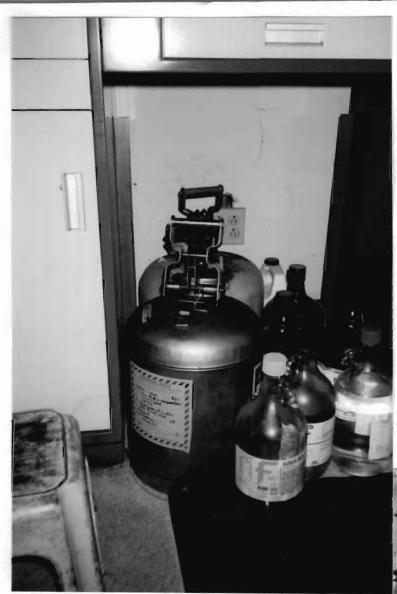
The laboratory, located northwest of the process area, is a satellite accumulation storage area for oily wastes, spent acid, and mercury (See photos #43 and #44). Waste oil and spent acid are generated as a result of analyses of incoming wastes, outgoing products, and wastewater discharged to the POTW. The spent acid is stored in a 5-gallon plastic carboy on the floor of the laboratory under a work bench. Waste oil is accumulated in a 55-gallon drum. The drum, containing the waste oil, is emptied weekly into a waste oil tank to be recycled in the refinery. Mercury waste results from broken hydrometers and thermometers. These broken hydrometers and thermometers are disposed of in a lab pack.

Photo #43: Photo of an accumulation storage area for spent acid.

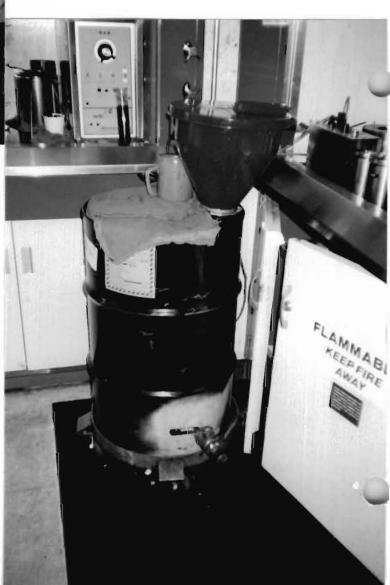
Photo #44: Photo of an accumulation storage area for waste oil. This accumulation storage area is in the laboratory.
